PROPERTY INSPECTION REPORT

Concerning: Somewhere Lane, North Richland Hills, TX 76182
(Address or Other Identification of Inspected Property)

By: Norman Smith, Lic #22683 09/10/2019
(Name and License Number of Inspector) (Date)

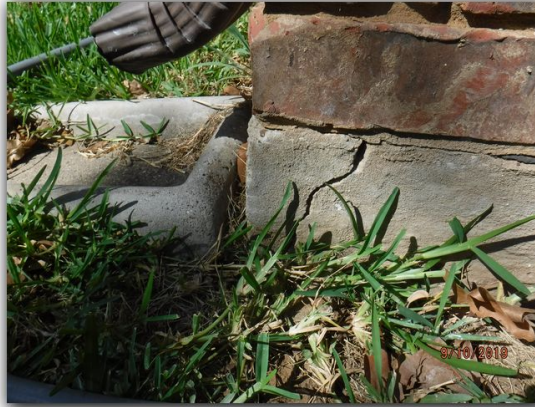
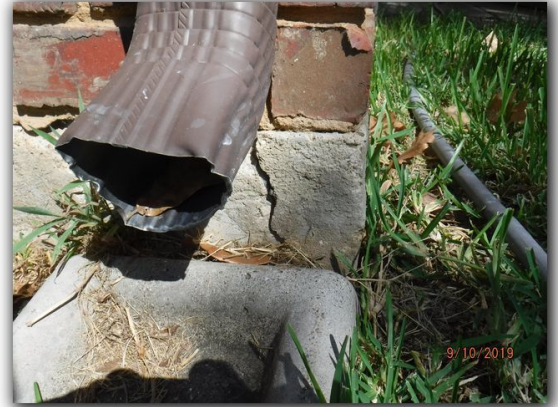
Corner pop on SE corner at front of house.

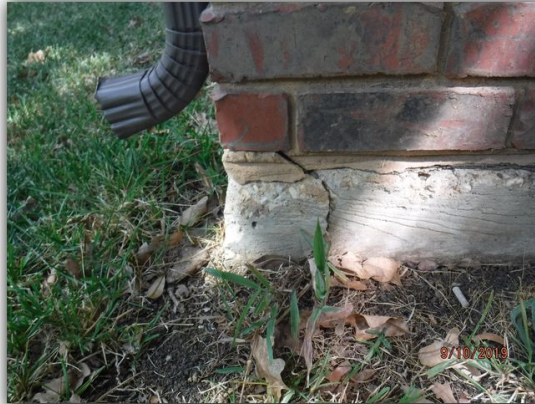
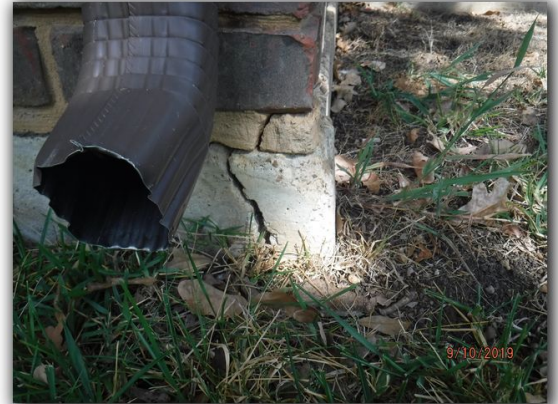
Corner pop on south wall near the AC unit

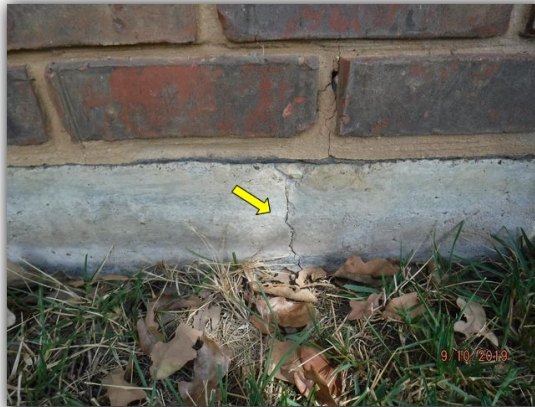
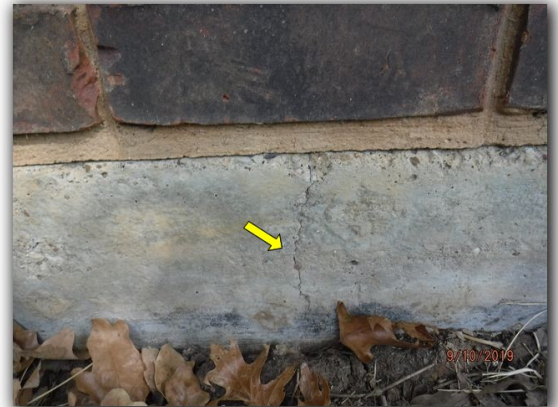
South wall foundation has two hairline cracks

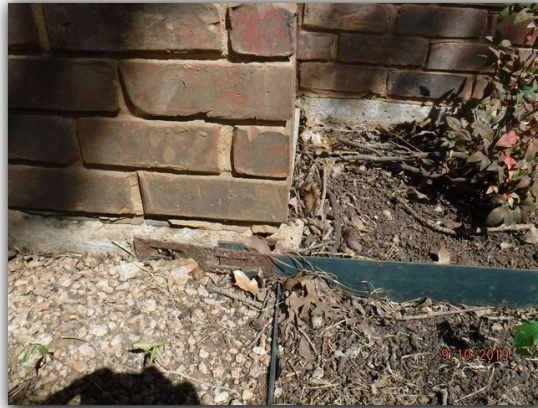
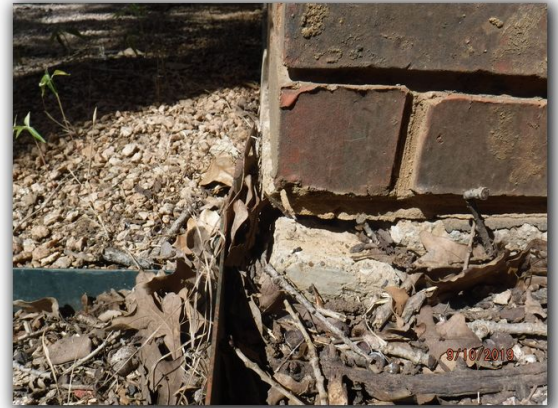
Corner pop on south wall about midway the wall

Due to the 1/4 inch crack on the west master bedroom brick wall and the master bedroom outside entry door that will not close, I recommend a structural engineer inspect the slab

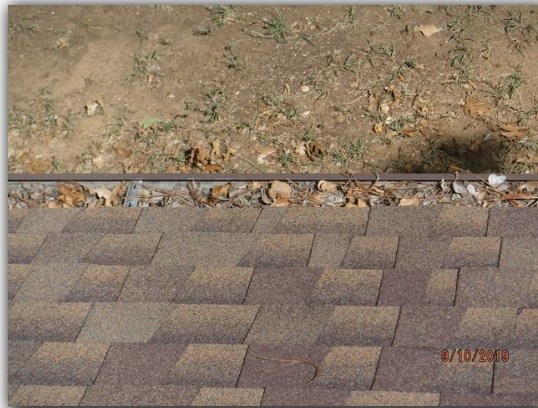
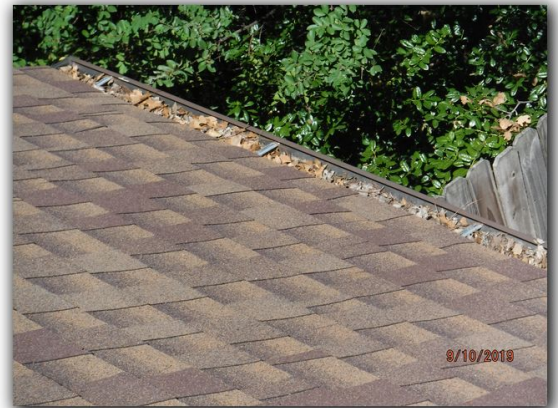
Gutters need cleaning

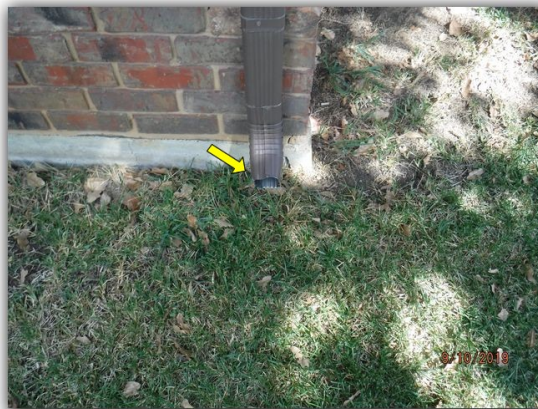
All downspouts that empty onto grass require splash blocks

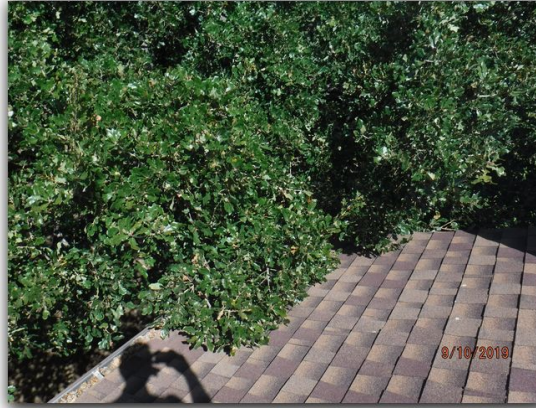
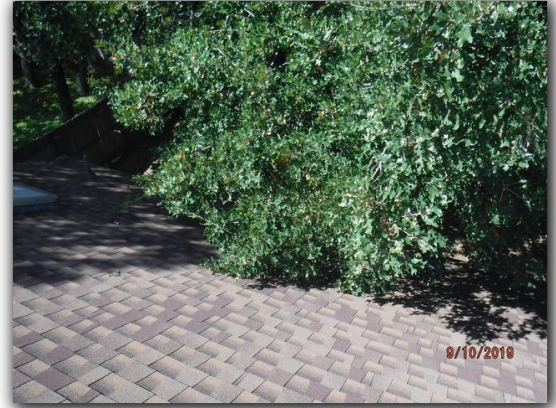
Limbs need to be cut back at least 3 feet from roof

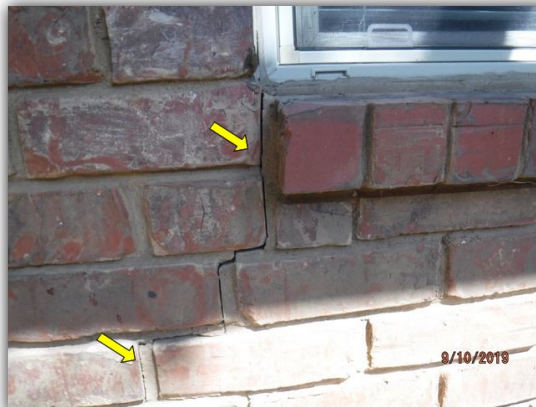
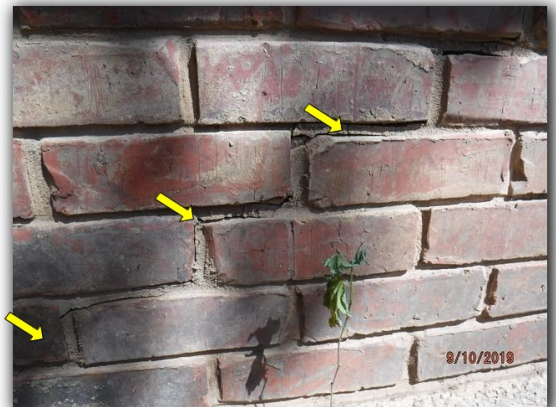
1/16 inch crack from corner of window to foundation on south wall

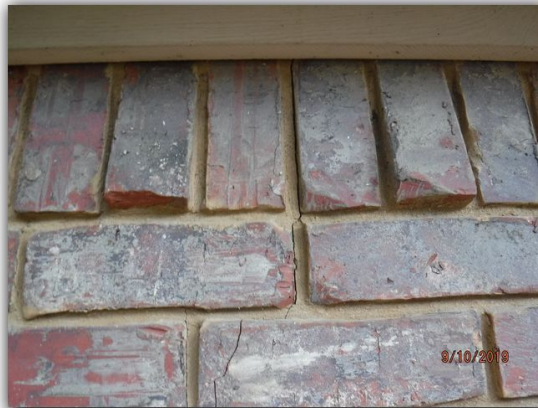
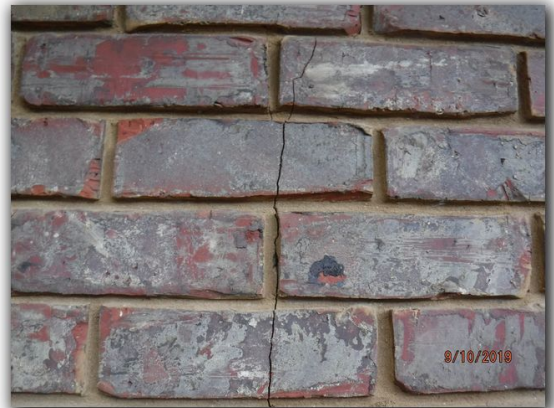
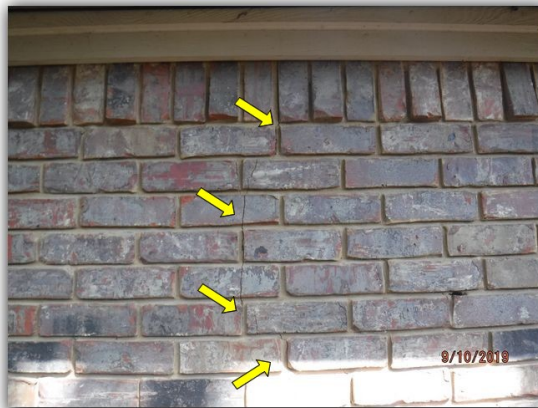
South wall, west end; 1/16 crack from top of wall to foundation

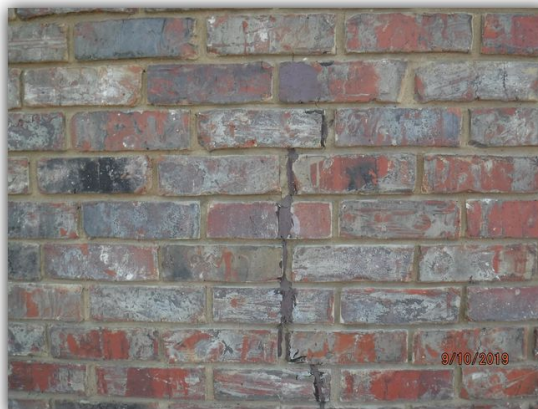
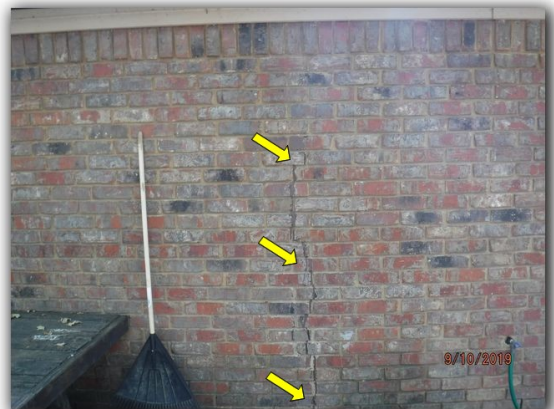
West wall serving the master bedroom has a 1/4 inch crack from upper portion of wall to foundation.

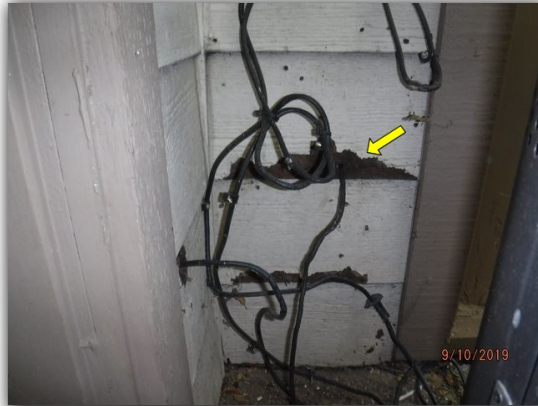
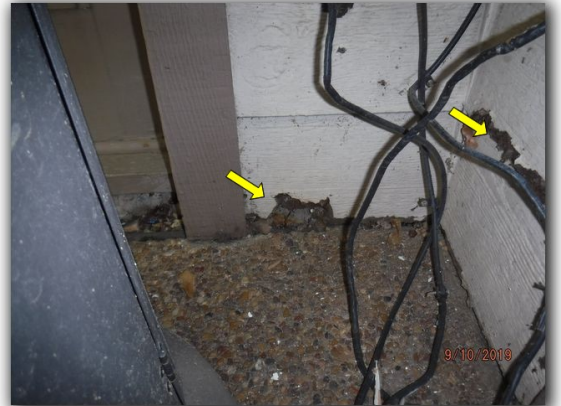
Rotted siding in corner of rear porch wall

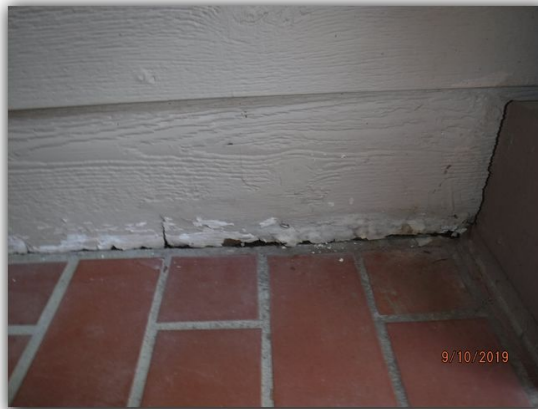
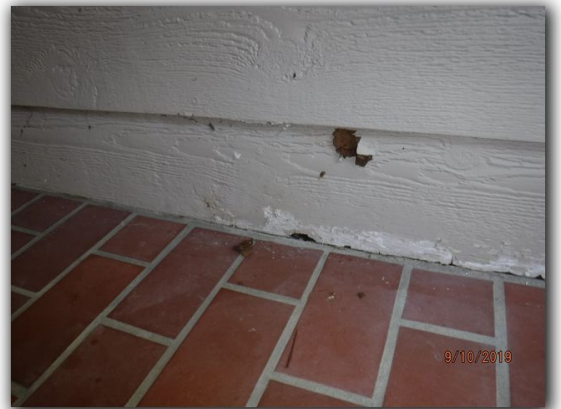
The front porch has rotted siding at the bottom of the wall. It also has two holes in the wall

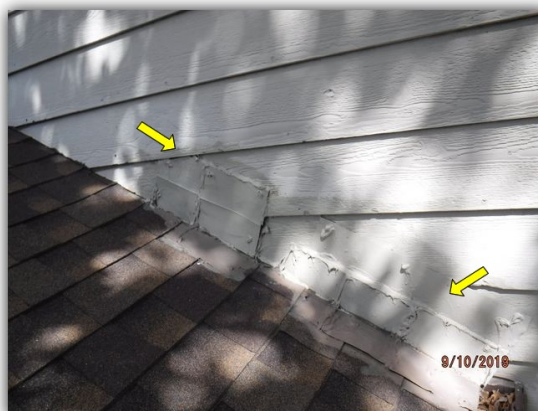
The upper outside walls have a lot of squirrel damage. This is especially apparent on the upper south wall. A portion of the damage was poorly repaired with metal and very likely to be leaking in a blowing rain

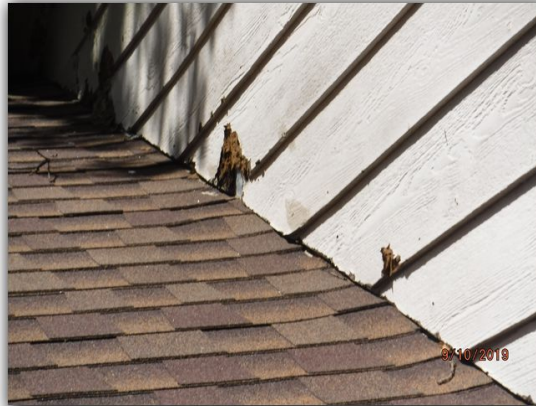
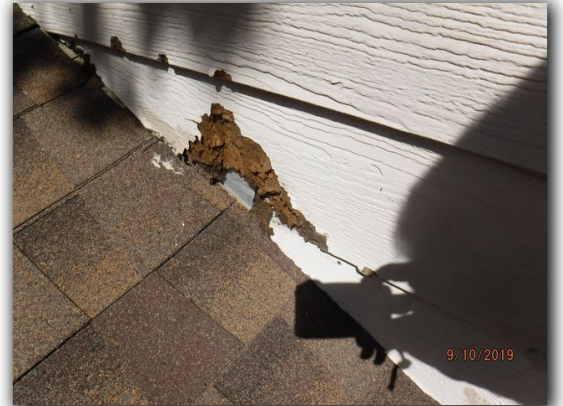
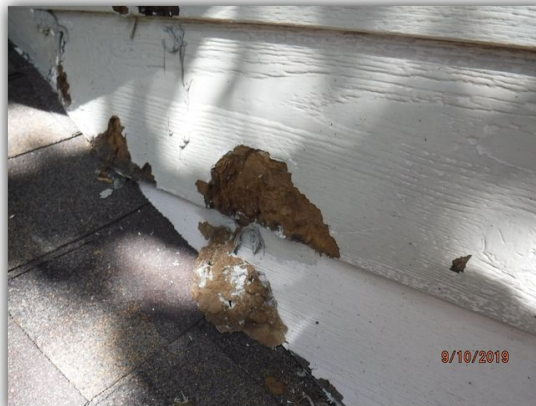
Going further up the same wall, more damage is seen. This siding is hardboard, which is easy vulnerable to damage from rodents. Recommend replacement with cement board

There were several places where some damage had been done by squirrels but the above is the worst

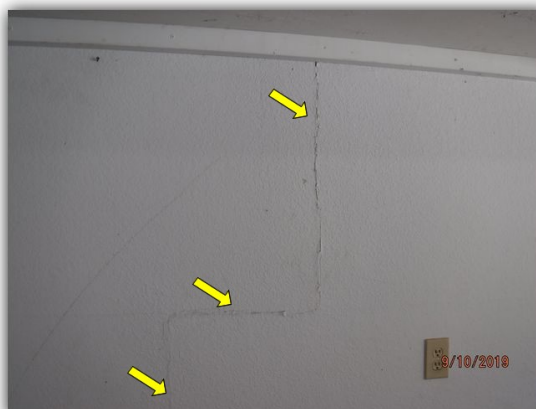
The garage wall is cracked in a manner suggesting foundation movement

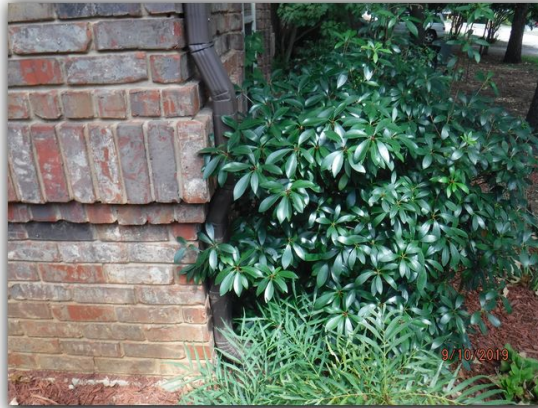
Vegetation should be kept at least one foot from wall

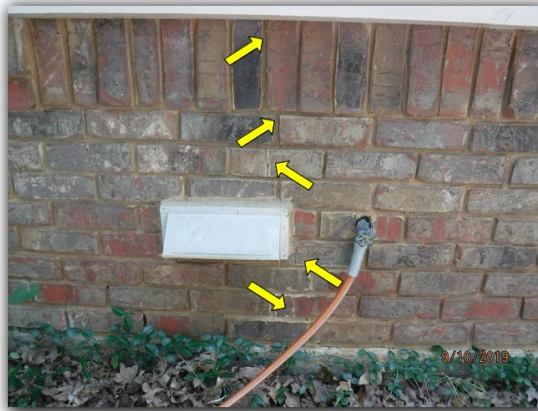
1/32 inch crack from center bottom of kitchen window to the foundation

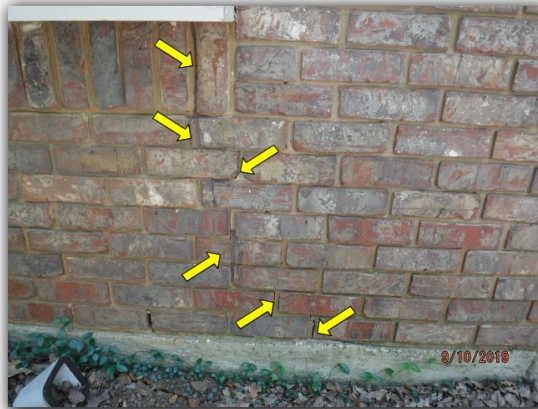
1/8 inch crack from corner of kitchen window to slab

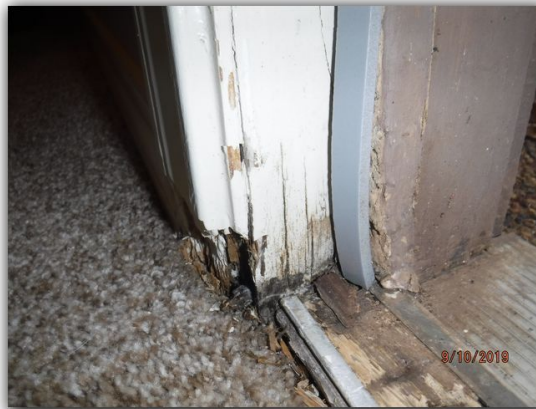
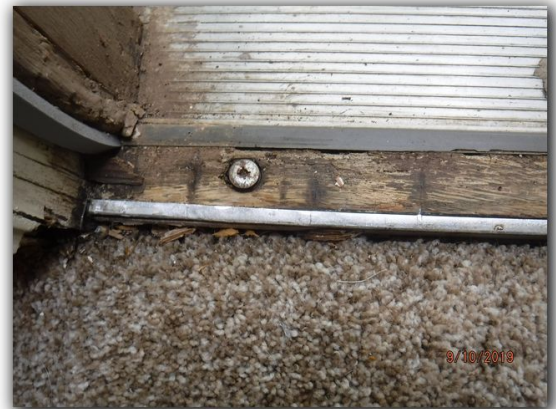
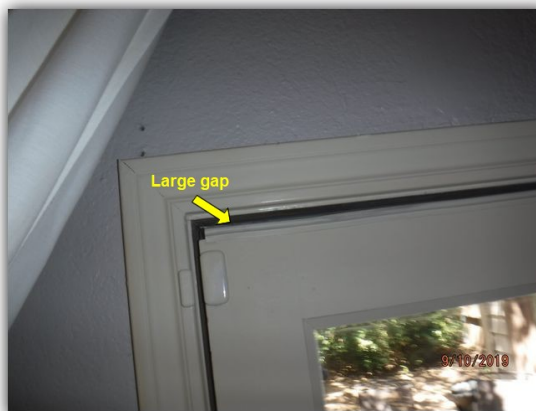
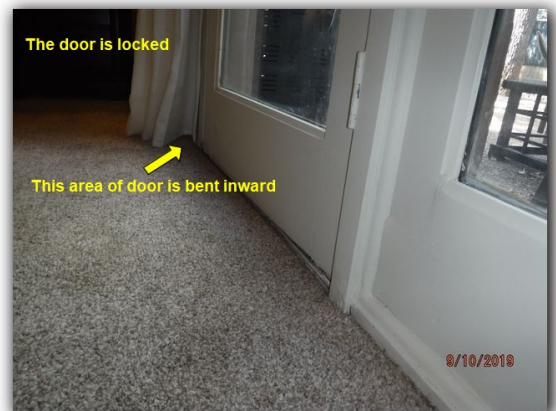
The outside entry door to the master bedroom is sitting crooked in the frame and the bottom of the door is catching on the threshold to the point where the door will not close properly. The door knob will not latch. The deadbolt will latch but forcing the door closed is required. The bottom of the door will not completely close no matter how much force is used. The door bottom hangs up on the threshold. The bottom of the door frame is rotted as well as the threshold.

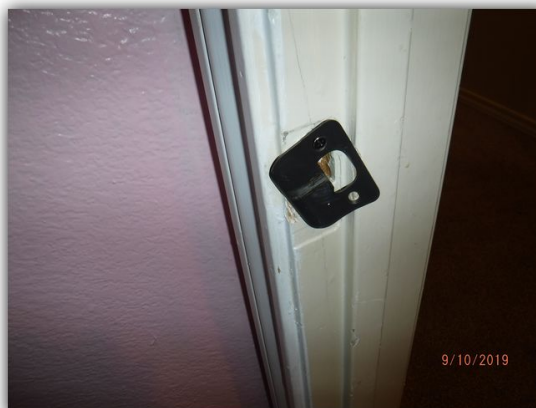
The middle bedroom door needs a new striker plate

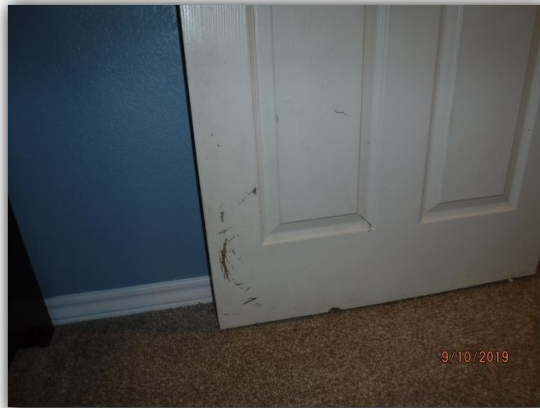
The front bedroom door is broken inside as if it had been kicked open

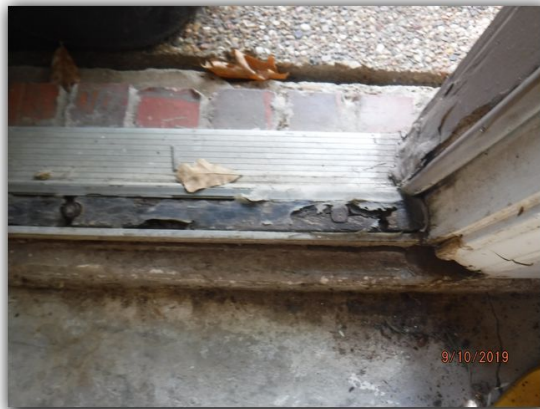
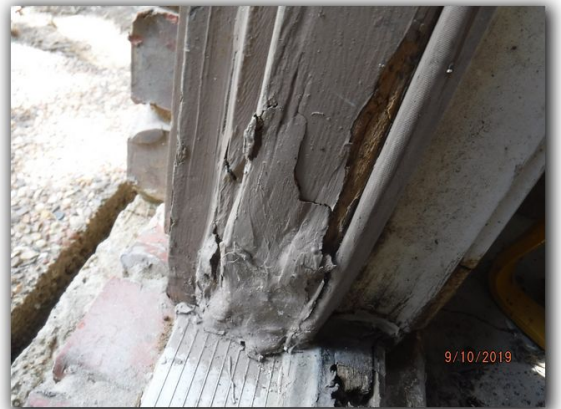
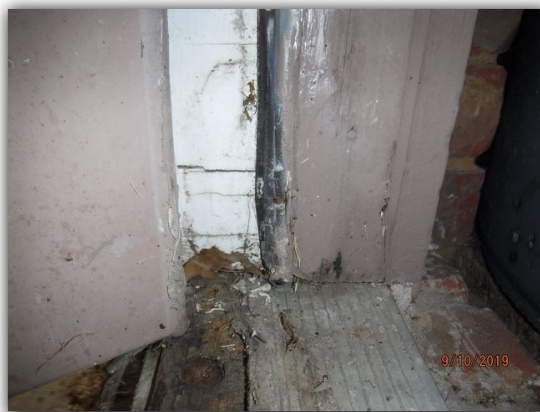
The garage side entry door has rotted wood at the bottom and rotted threshold weather stripping

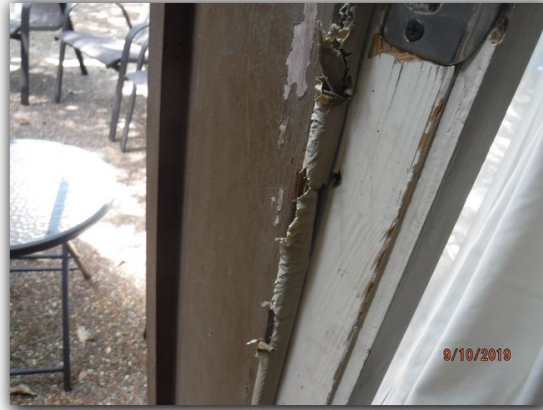
The back door weather stripping is worn

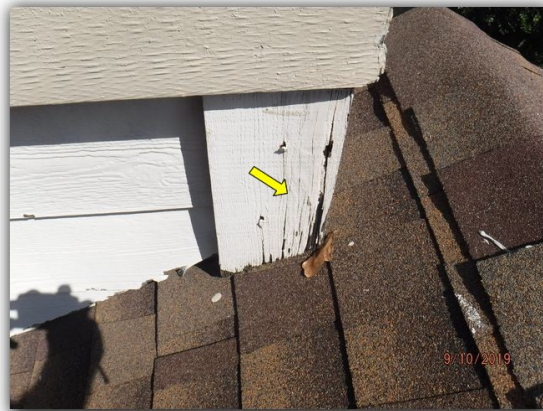
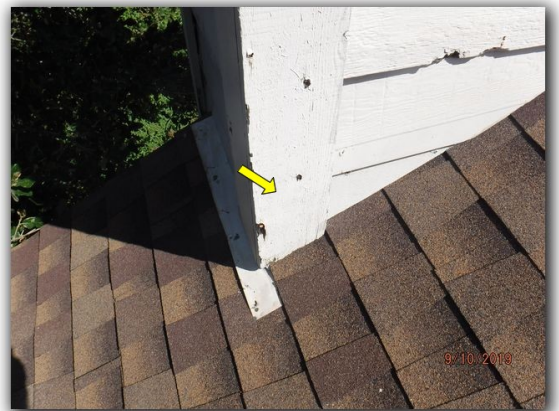
The chimney has some rotted wood

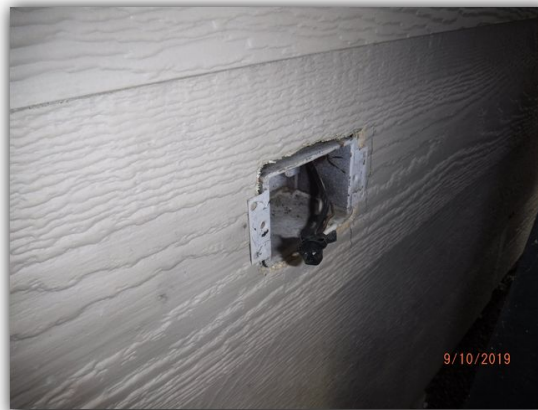
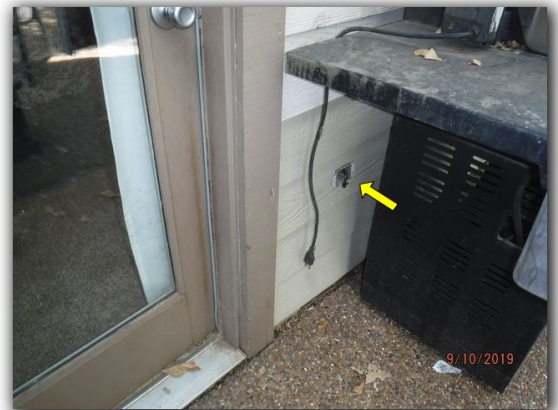
There is an outlet box on the back porch that has no outlet installed. The wires are sticking out of the box. The wires tested as being live. This is a very dangerous and requires correction. An outlet and an in-use cover should be installed

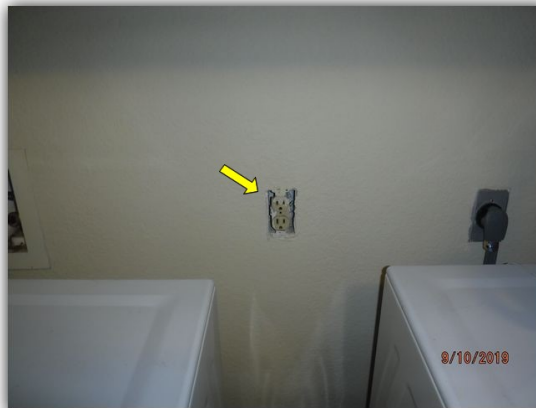
The laundry room outlet has no cover

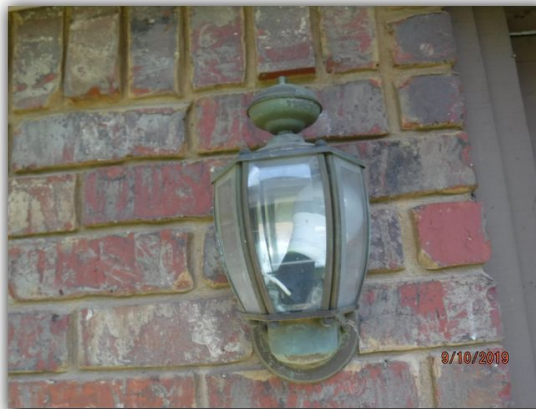
South wall light fixture has bulb sitting sideways. The light works

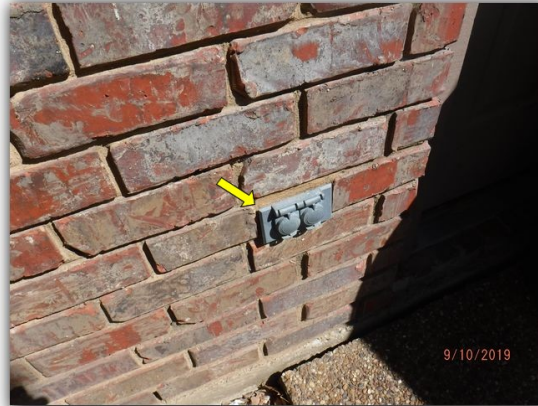
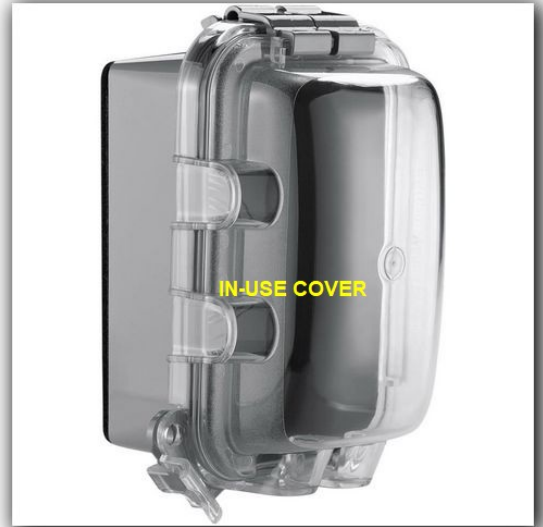
South wall outlet needs in-use cover

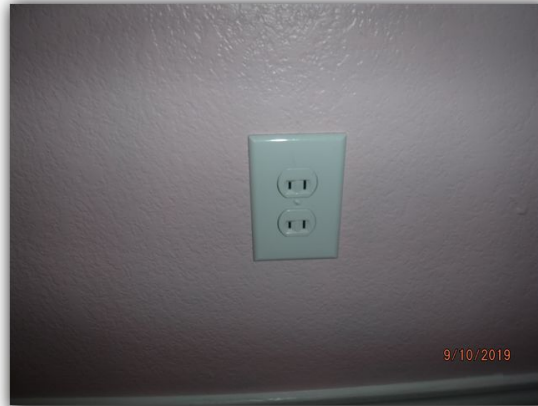
The middle bedroom has an ungrounded outlet installed. I would have to assume that there was a problem that required replacement of the outlet and the buyer picked up the incorrect outlet. It will work as long as there is not a grounding lug on the plug

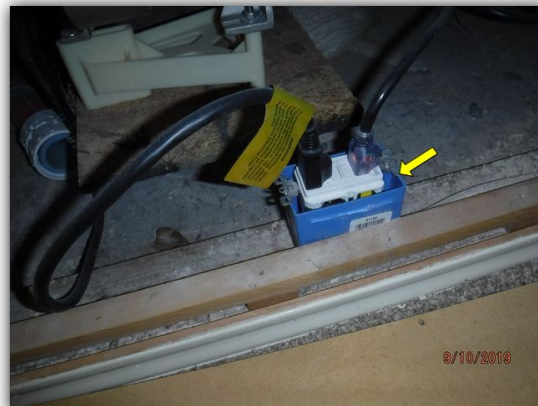
No cover on the receptacle serving the pump for the master bath tub

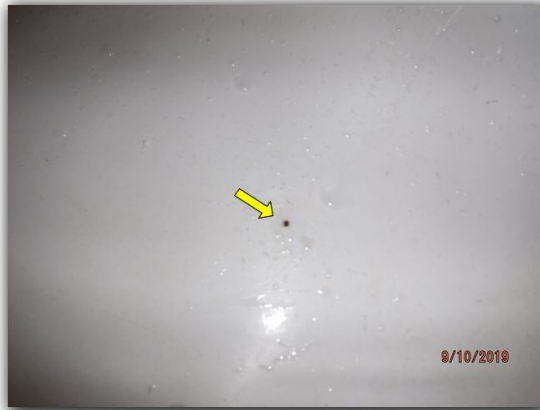
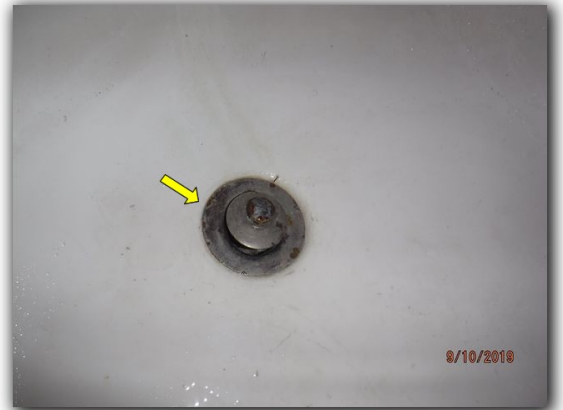
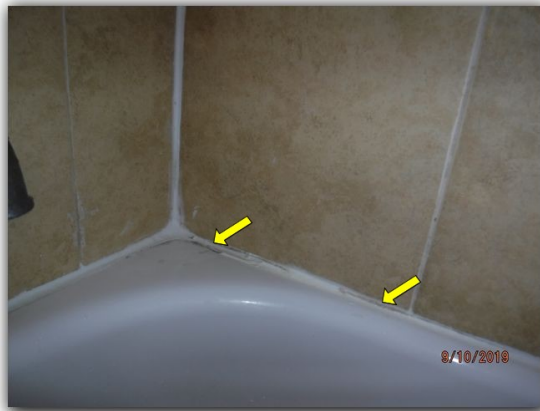
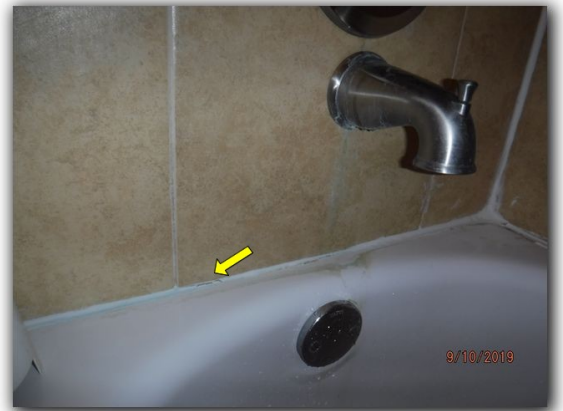
Tub in hall bath has a small chip in the bottom, a corroded drain, and the caulk around the tub rim needs attention

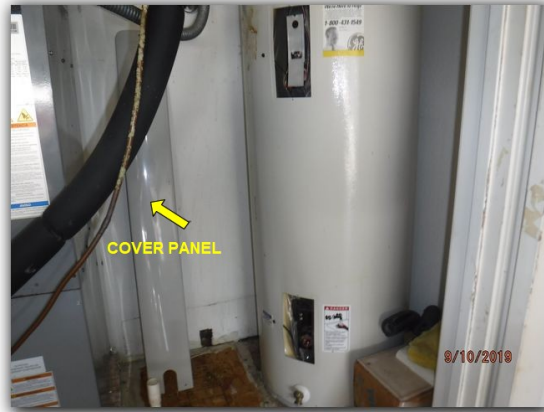
The front cover was not installed on the unit. This leaves the electrical wires exposed and could be fatal if touched. The panel requires installing

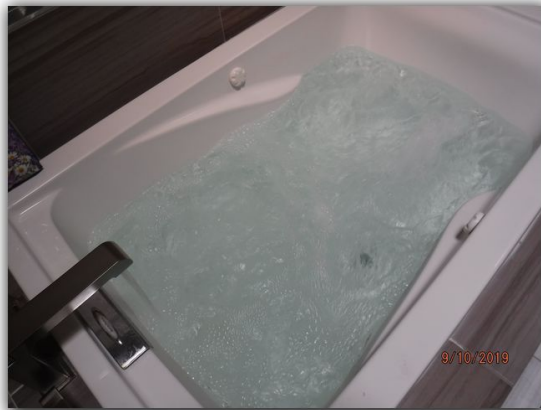
The stopper did not stop the water from leaking out. I had to use my personal stopper to test the tub.

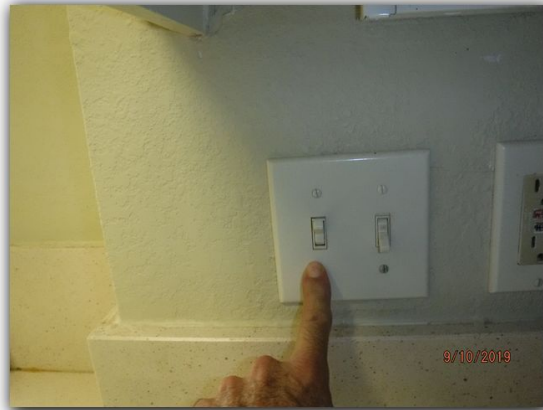
A switch over the countertop turns the power for the dishwasher on and off. A very unusual arrangement

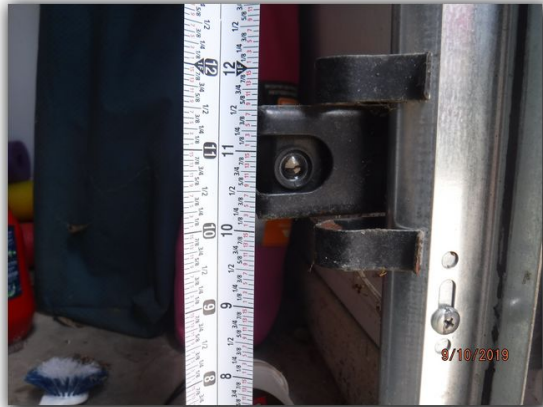
The electric eye should be no more than 6 inches off the floor. This one is 11 inches

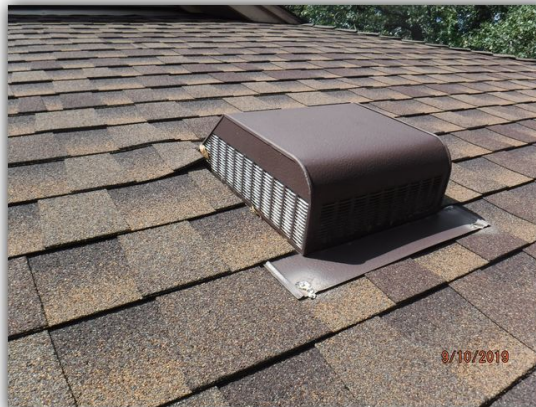
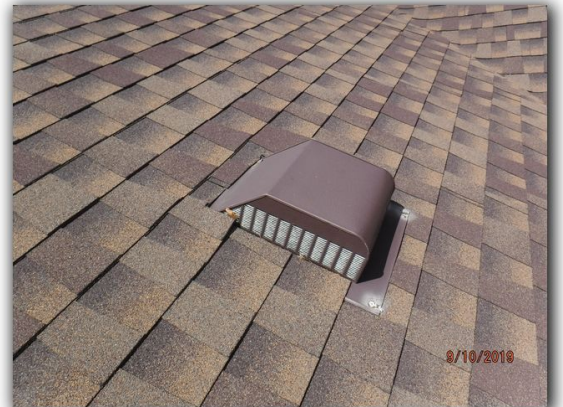
The dryer vent exits through the roof. The roof vent is totally incorrect for a dryer vent. It has small vent slits that trap the lint. It is completely clogged. The vent requires replacement with an appropriate vent.

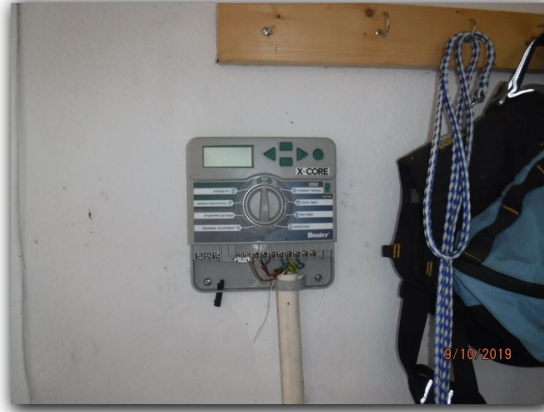
The sprinkler controller is not powered. I could not test the system
