Peak Property Inspections

PROPERTY INSPECTION REPORT

| Prepared For: | John Doe | |
|---|--|---|
| Concerning: | 4040 John St, Rouse, TX 00000 (Address or Other Identification of Inspected Property) | |
| By: | Norman Smith, Lic #22683 (Name and License Number of Inspector) | 11/02/2019 (Date) |

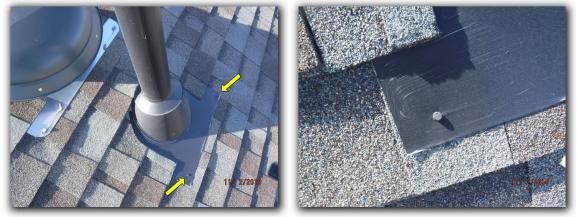
Types of Roof Covering: Asphalt Shingles Viewed From: roof Comments: The nails holding down the bottom of the gas vent flashing are not caulked

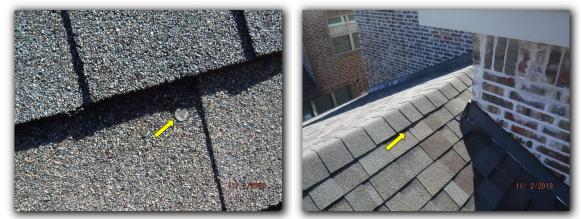
The is a nail in the surface of a shingle on the lower section of roof, west slope, near the top. The nail should be pulled and the shingle replaced

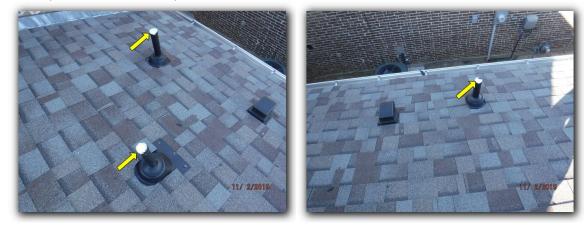
The plumbing vents on the lower roof, west slope, are capped. They may have been left there after a pressure test. The caps should be removed.

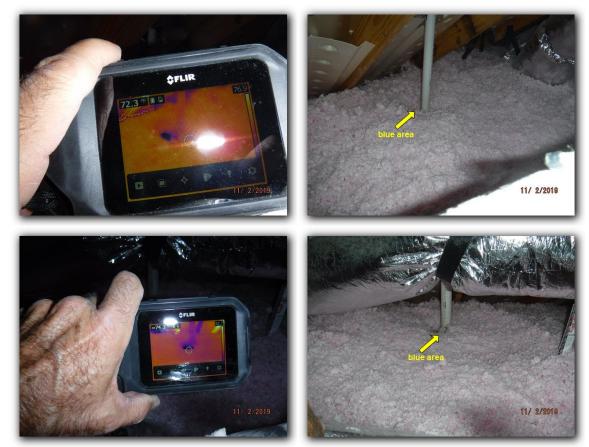
I than went into the attic accessed by the hallway pull down stairs. I had seen evidence of moisture in the ceilings of three different bathrooms so I did a thermal imaging test of the roof vents where they came through the insulation on their way up towards the roof. All three vents that I could see from that attic had cold spots where the vent pipes entered the insulation. Cold spots usually mean the presence of either cold air or water. I was unable to reach the area where the pipes came through to test for moist insulation.

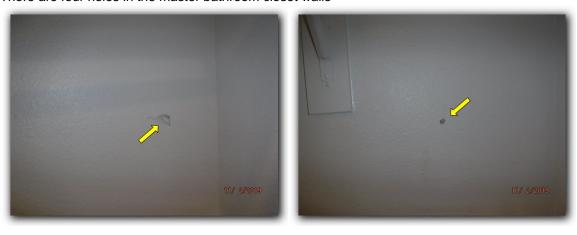
Comments: There are four holes in the master bathroom closet walls

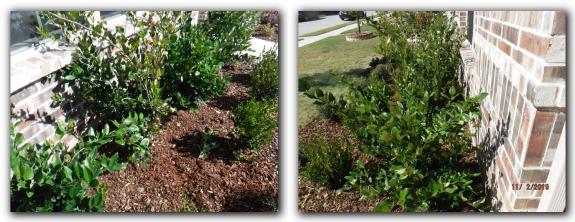
Bushes planted too close to walls at front of house. Vegetation should be kept at least 12 inches from a wall

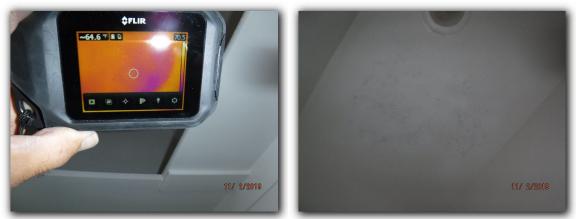
The ceiling in the rear closet of the upstairs Jack and Jill bath is moldy and shows as moist on the thermal camera. By the way, the white flash is my camera flash and should be ignored.

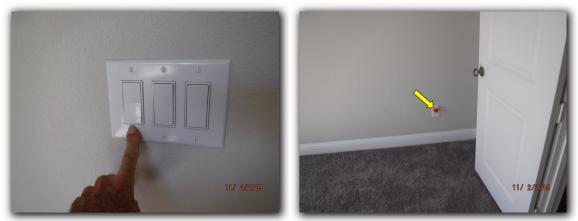
For information only; In the master bedroom, the switch indicated operates the top section of the outlet shown.

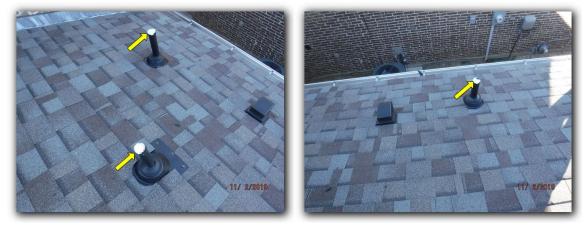
Comments: Three vents on the roof are capped. Caps should be removed for proper operation of the vents

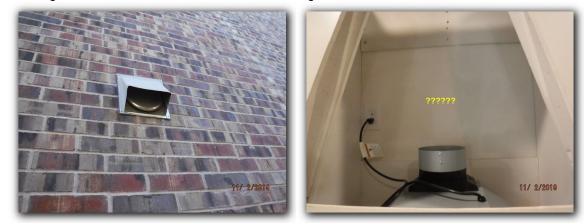
Comments: The vent hood is not hooked up to the outside vent. In fact the vent outlet cover is showing on the brick wall but the inlet is not showing on the inside wall
