PROPERTY INSPECTION REPORT

Concerning: Somewhere Lane, North Richland Hills, TX 76182
(Address or Other Identification of Inspected Property)

By: Norman Smith, Lic #22683 09/10/2019
(Name and License Number of Inspector) (Date)

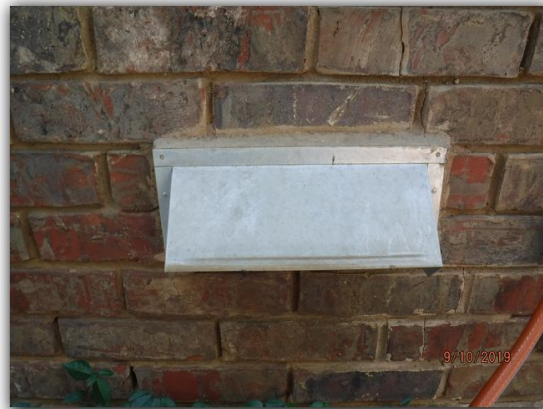
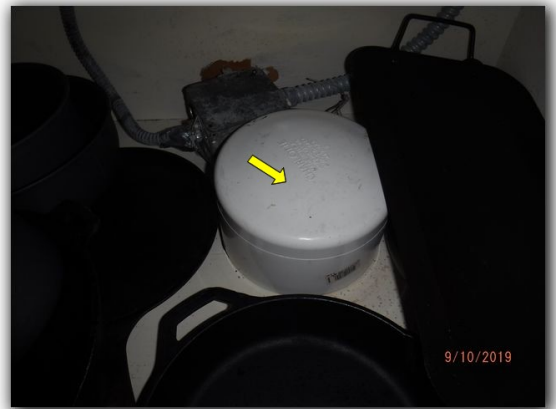
The cooktop is installed on the island. The island has a provision for a downdraft cooktop

The oven light does not come on
