Peak Property Inspections

PROPERTY INSPECTION REPORT

| Prepared For: | John Doe | |
|---|--|---|
| Concerning: | 4040 John St, Rouse, TX 00000 (Address or Other Identification of Inspected Property) | |
| By: | Norman Smith, Lic #22683 (Name and License Number of Inspector) | 11/02/2019 (Date) |

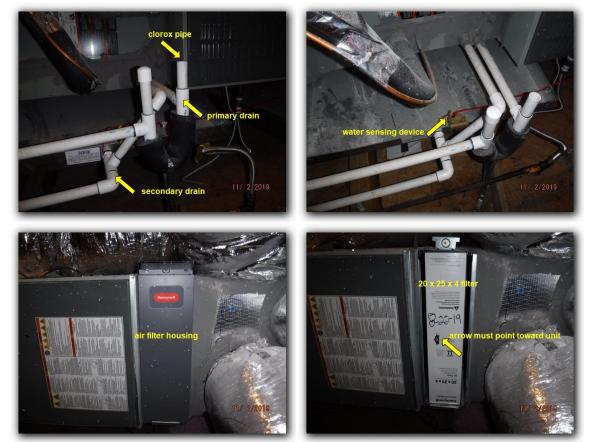
Your system has a water sensor in the drain pan under the air handler that will shut off the unit if water is detected
